FROST HOME INSPECTION

Inspection report for: Clients name
Inspection location: site address
Any town or city
Georgia

INSPECTION CONDITIONS REPORT

REPORT SUMMARY

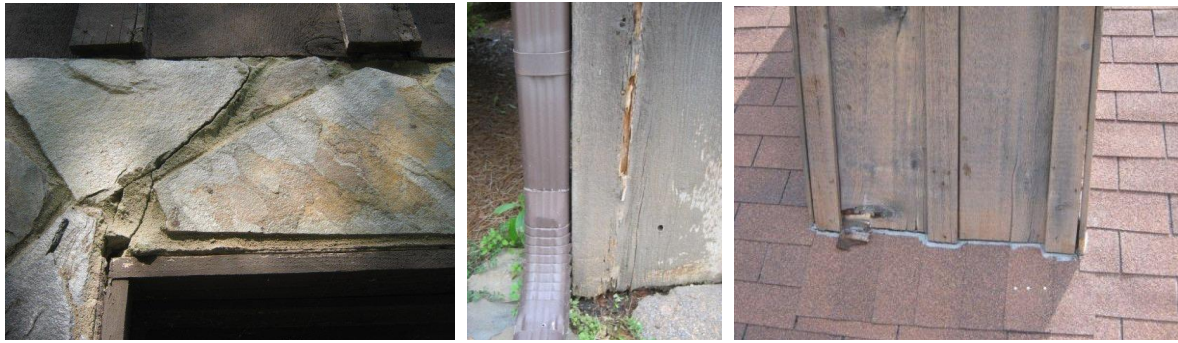
Exterior surfaces/stone veneer/wood siding

1. The stone veneer at the left side has cracks present above the garage door and window areas. The window and door frames appear to have no lintels to properly support the weight of the stone veneer wall. Recommend restructuring the entry ways to the basement at the left side and at the rear entry to support the doors and windows.
2. The wood siding at the front right corner and at the upper chimney area have signs of wood deterioration and damage possibly due to moisture or previous signs of termites at the right front corner.

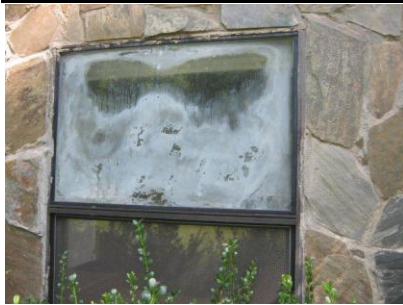
3. Windows at rear portion of the house basement area have signs of failed insulated glass seals.

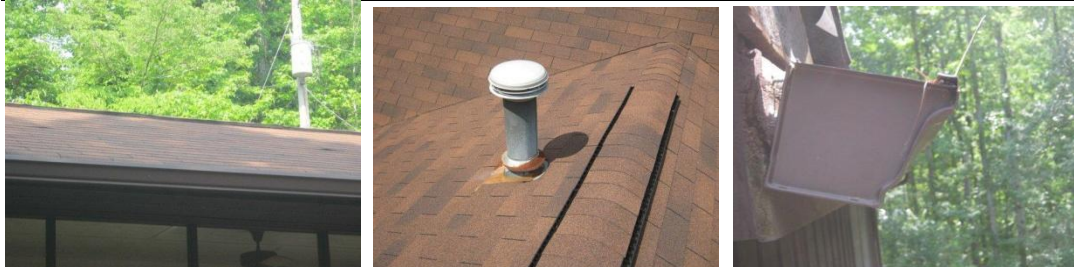
Roof and gutters

4. Roof covering at the rear patio area have signs of lifted shingle due to pop up nail fasteners.
5. The metal flashing at various locations of the roof vents and roof fans have signs of rust and corrosion.
6. Gutters located at the rear portion of the house over the deck and at the rear portion of the house right rear patio area have signs of detached fasteners and negative slope not allowing moisture to drain properly.

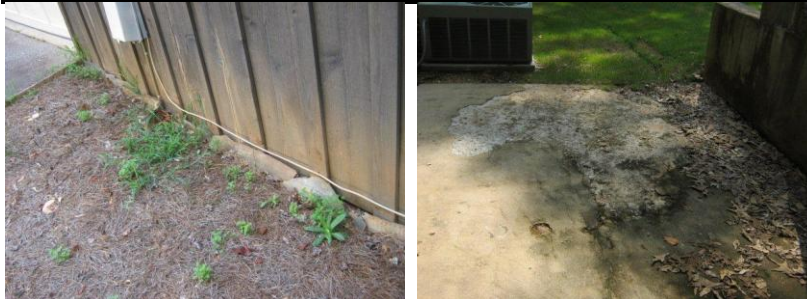
Lots and ground – grade

7. The grade at the right rear area appears to slope towards the house. The grade at the rear area underneath the deck at the patio appears to slope towards the rear patio area. Negative slope conditions may contribute to previous signs of moisture in basement and rear patio underneath deck area.

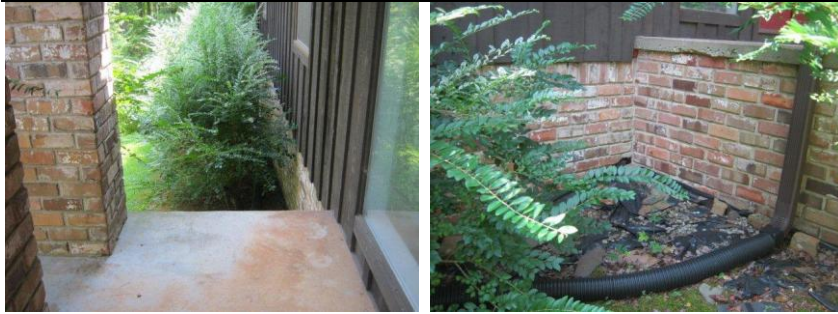
Front porch

8. The front porch area does not have a guard rail with balusters no further than 4 inches apart due to the safety issue at this location recommend installing a guard rail and balusters to help prevent safety and all has at the elevated area of more than 30 inches. Recommend installing guard rail at least 36 inches high.

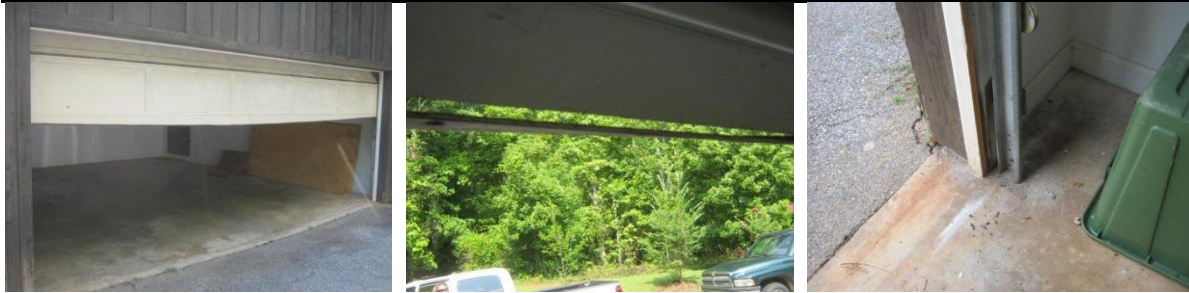
9. The garage door appears to be cut to the slope of the garage slab floor. This condition is not a defect. The slope of the garage slab floor appears serviceable and sloped properly to the edge and drive way area.
10. The gaskets seal for the garage door appears to be loose. Recommend attaching seal to door to prevent moisture intrusion into the garage area.
11. Garage door opener does not have auto sensor reverse mechanism installed. Recommend installing the auto sensor reverse switch to allow door to reverse in the event of obstruction.

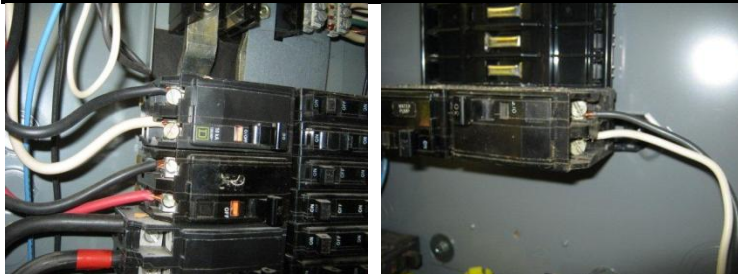
Electrical service/panel/wiring/outlets

12. The electrical wiring (Romex) has hot white wiring present at the top left double circuit breaker of the main panel and at the lower right doubles circuit breaker of the subpanel. White wiring is normally used for neutral wiring at buss bars and at ground fault or arc fault breakers. Recommend marking hot white wiring to indicate live current present at these locations.

13. Panel cover for the subpanel as open knockouts with duct tape covering openings. This is not an acceptable condition recommend a licensed electrician install knockout covers at the subpanel.

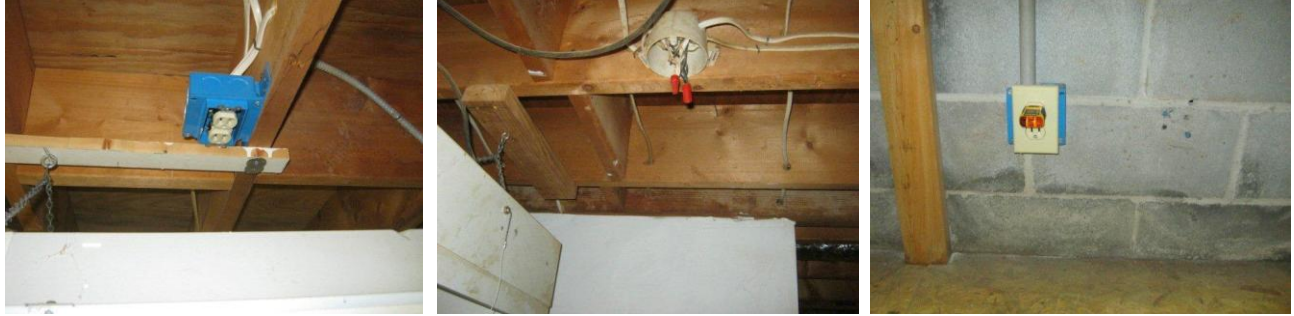
14. Uncovered outlets located at the basement ceiling framing area at the right side above lights. Open junction boxes are located at the rear right area and at the front right area of the basement exposing hot wiring. Outlets at the right basement area do not operate when tested. Recommend a licensed electrician to all repairs and service to the electrical components outlets and junction boxes

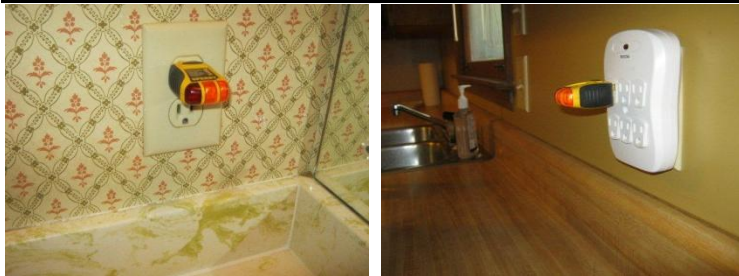
Ground fault circuit interrupters

15. The outlets located at bathroom into the sink areas are not ground fault protected. Recommend a licensed electrician install GFCI outlets at the bathroom sink areas and at the kitchen sink area.

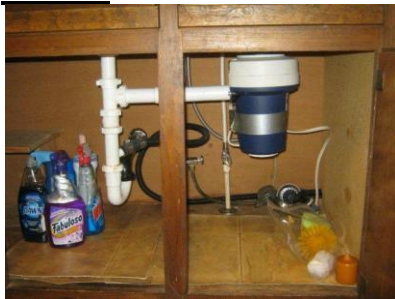
Kitchen

16. The kitchen sink has a garbage disposal installed with septic tank present at this property. Disposal is not recommended for a property with septic tank present.

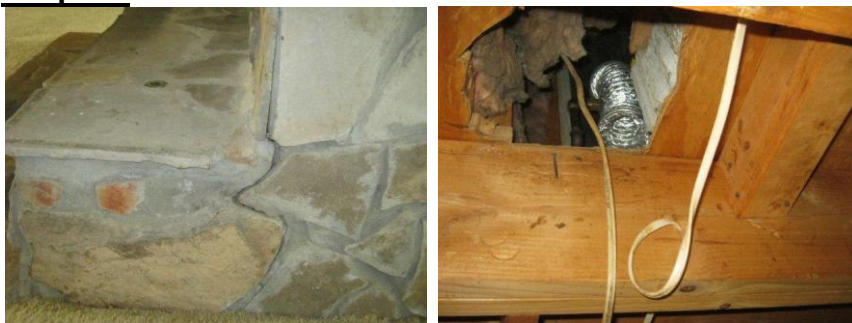
17. Fireplace has signs of previous settling due to cracks located at the stone and mortar on the right and left front corners of the fireplace hearth.

18. The fireplace combustion air that is in proper and terminates inside or framing of the basement area located below the fireplace. The vent pipe is improper material. Recommend installing a metal vent pipe to extend and discharge to exterior location.

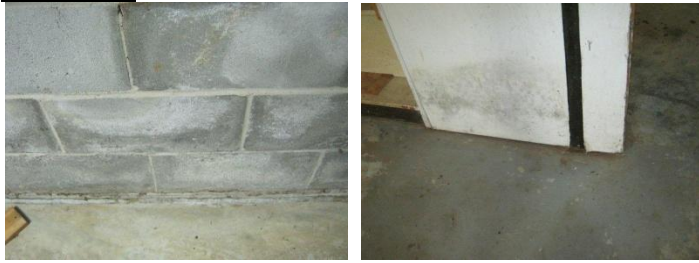
Basement

19. Signs of previous moisture stains are located at concrete block wall in the basement at the right and front sections of basement. No signs of moisture current or ongoing are present at the time of inspection.
20. Signs of moisture are present in previous conditions at the left rear basement room where drywall is present. Drywall has signs of mildew present due to previous moisture intrusion. Recommend an air quality control tests be performed and recommend all signs of mildew be removed and repaired at the drywall locations of the rear left basement area.

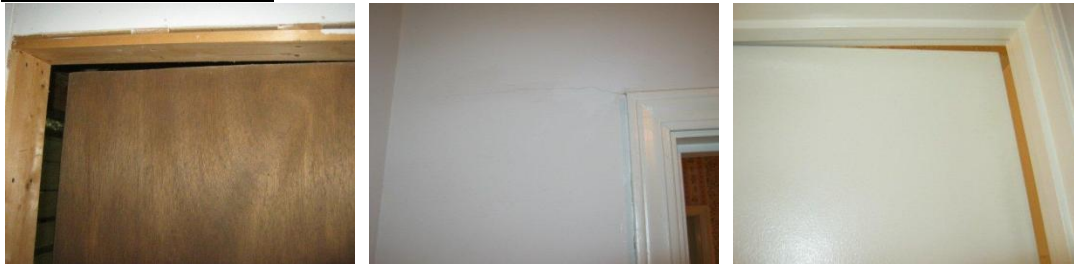
Structure/doorways

21. Signs of possible settling appear to have occurred at the left rear basement structure and main floor area. The doorway at the rear left basement finished area and the doorway at the main floor rear left bathroom closet have signs of settling due to uneven doors cracked drywall and doors seizing at door jams and unable to close. Recommend a structural contractor evaluate to assess further support in these areas or to even door jams at these locations to allow doors shut proper.

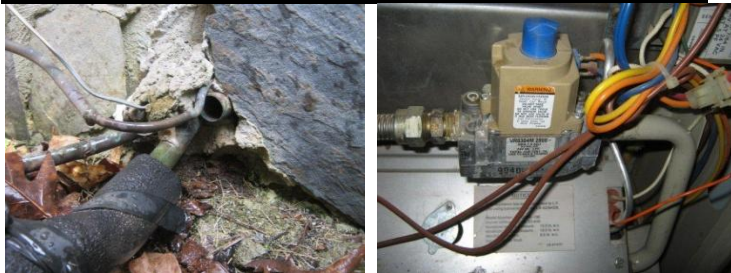
AC unit condensate lines/ HVAC fuel line and valve

22. AC unit condensate line terminates and discharges at the stone veneer and foundation grade area. Recommend extending the condensate line to terminate away from the foundation to help prevent deterioration at the mortar and help prevent moisture intrusion at the basement foundation.
23. According to the HVAC specialist that tested and evaluated the burners and fuel line and valve the fuel valve needs to be converted to an LP fuel valve. Recommend fuel valve convertor be installed to comply with the LPG type of fuel supply.

FUEL LINE/CONDITION: **Defective** / According to the HVAC specialist that tested and evaluated the burners and fuel line and valve the fuel valve needs to be converted to an LP fuel valve. Recommend fuel valve convertor be installed to comply with the LPG type of fuel supply.
